# **GREAT GRANSDEN CHURCH**

**A report on the bellframe**

## The bellframe at Great Gransden church (Diocese of Ely)

A report by Christopher Pickford FSA for the Historic Bellframes Rescue Recording Project - Oct./Nov. 1994.

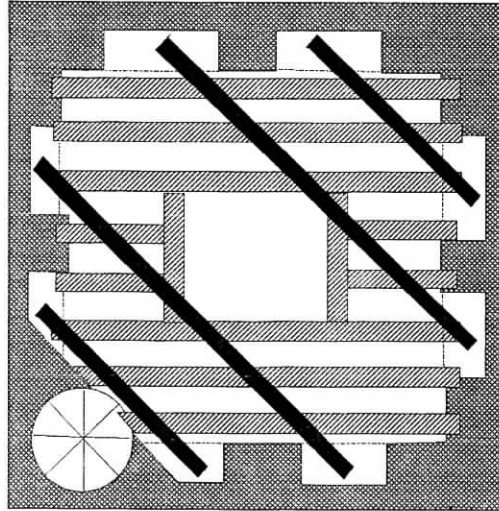
- 6.2 The four main foundations beams of the frame rest on an older grillage of beams supported on ledges or off-sets on the east and west sides of the tower. The main beams (i.e. the sills of the deep trusses as described in s.8 below) span the tower diagonally from NW to SE and are situated below the corresponding heads of the frame. The arrangement is shown in the following plan.

The main foundations beams (in black) resting diagonally on a grillage of older timbers

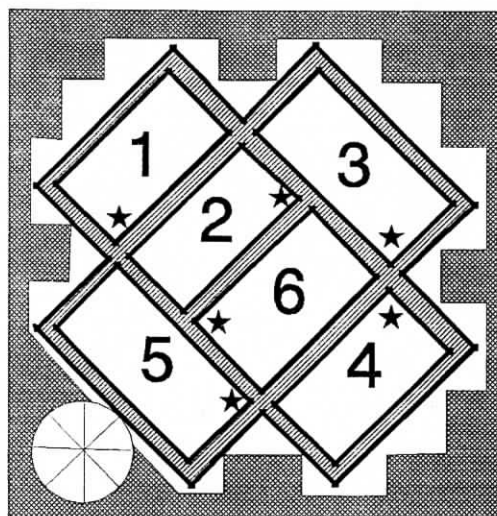
Plan of the frame (with roping positions)

- 7.1 The frame was built in 1658 to accommodate six bells on one level. The plan has four bells in parallel pits across the centre of the tower, with single bells in pits at right angles to each side. The plan of the frame remains as originally constructed and has not been modified, although the roping positions may have been altered. The date "1658" is carved on the head of the frame at the entrance to the bell chamber from the spiral stairs.

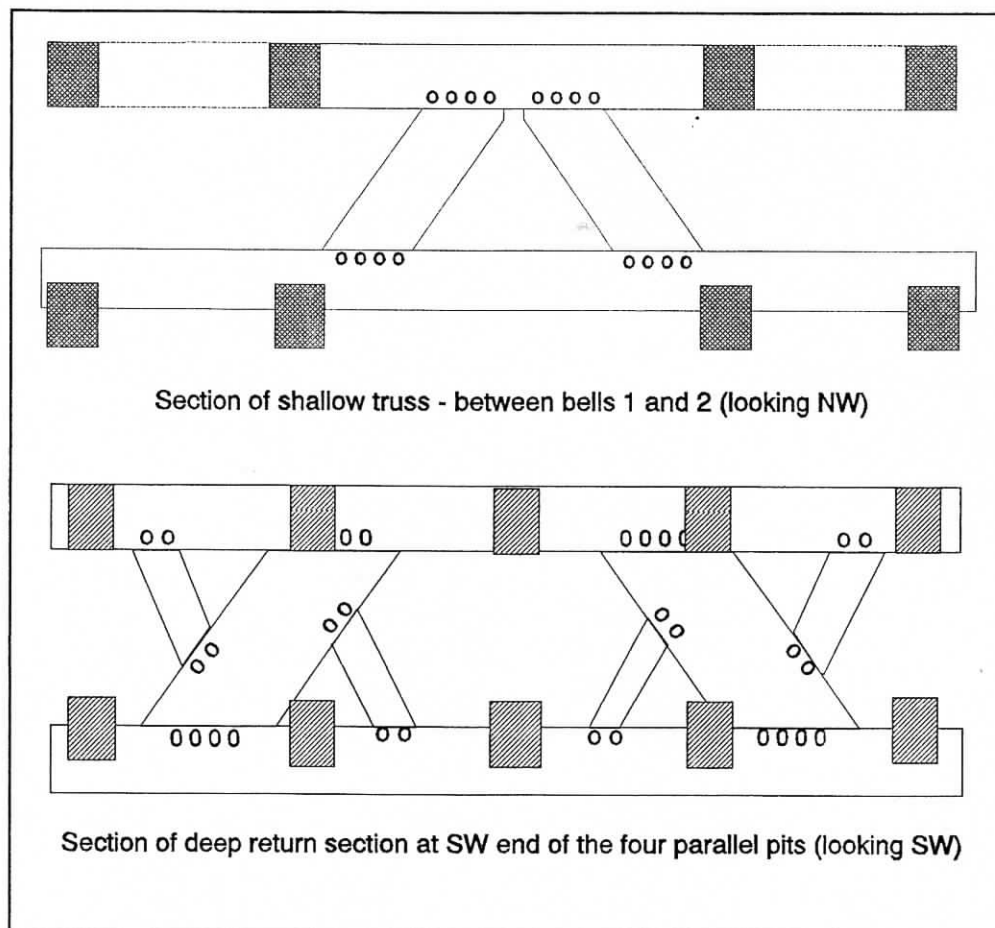
- 8.2 The arrangement of the sills on two levels provides two pits (bells 3 and 5) with deep trusses and four (the parallel pits) with shallow trusses. The construction and depths of the main trusses are shown in the following diagram:
