REPORT OF STRUCTURAL INSPECTION AT:-

**THE TOWER OF THE PARISH CHURCH ST BARTHOLOMEW'S
GREAT GRANSDEN, CAMBRIDGESHIRE**

A. DEMPSTER BSc CEng MStructE MICE

**FEBRUARY 1995
JOB NO: 21/160**

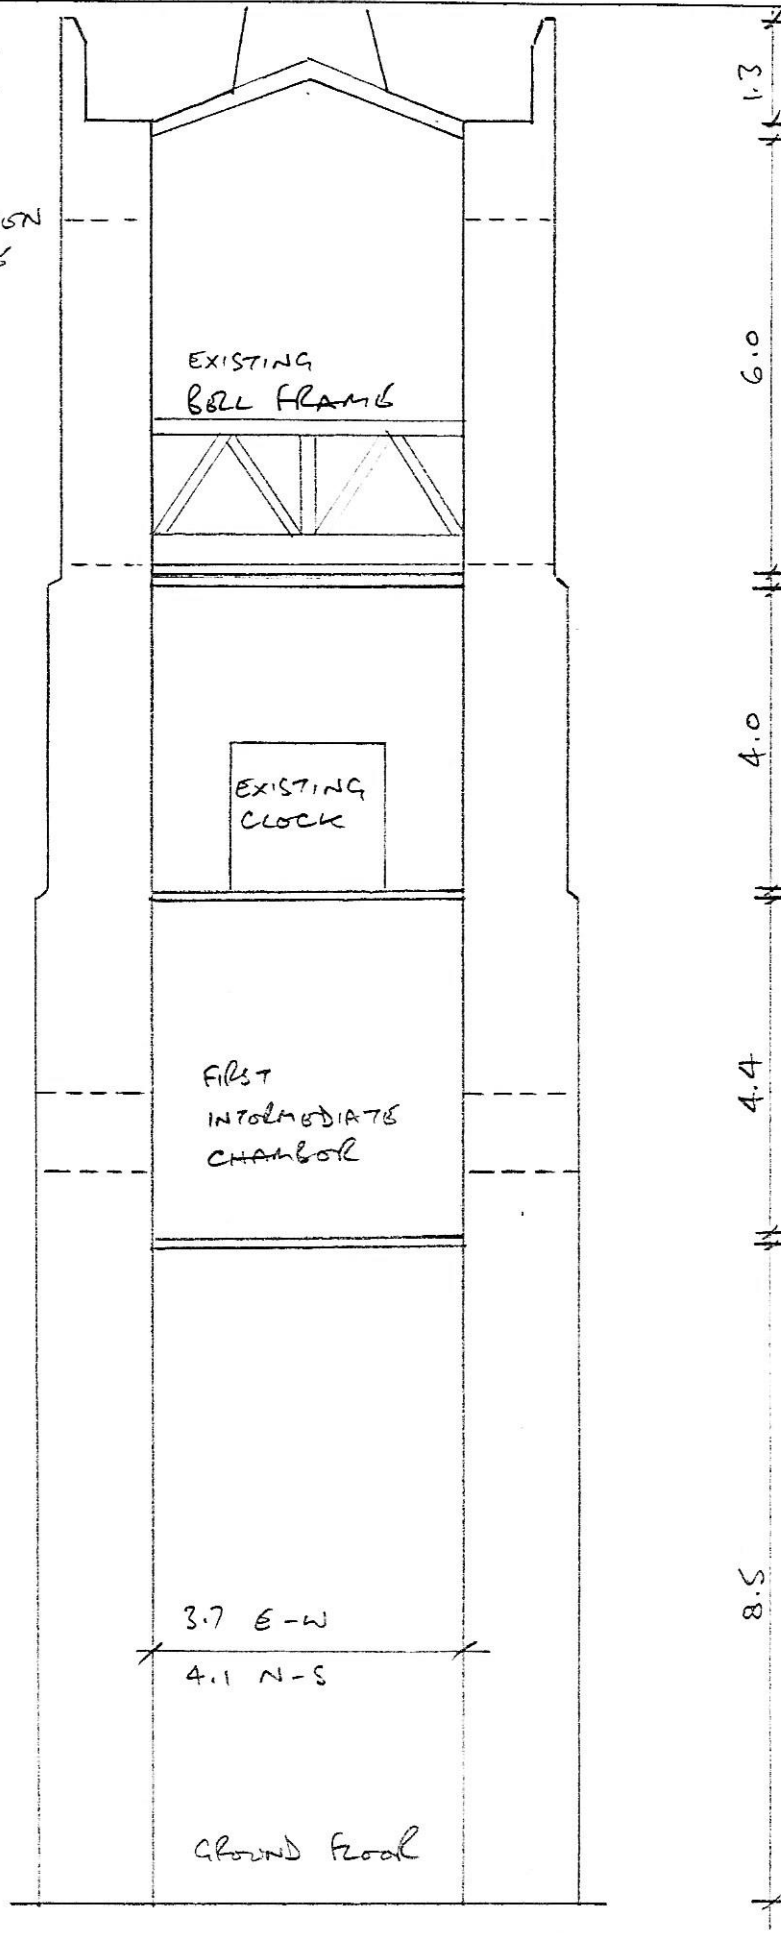
TYPICAL CROSS
SECTION(DIMENSIONS GIVEN
ARE APPROXIMATE
ONLY)

It should be noted that the stiffness of the tower at any level is proportional to the cube of its height above ground level. The height of the existing bell installation is approximately 17m above ground level and the height of the proposed installation is approximately 13m above ground level. Since the

horizontal deflection is directly proportional to the tower stiffness it follows that there is a further reduction in horizontal deflection of approximately 56 per cent if the bells are hung in the existing clock chamber.

It is considered therefore that there are significant structural advantages in rehanging the existing ring of bells at a lower level in a rigid metal frame and at the level and in the configuration shown in Appendix A to this report. It is considered unlikely that the new installation will have any significant detrimental effect on the tower structure.

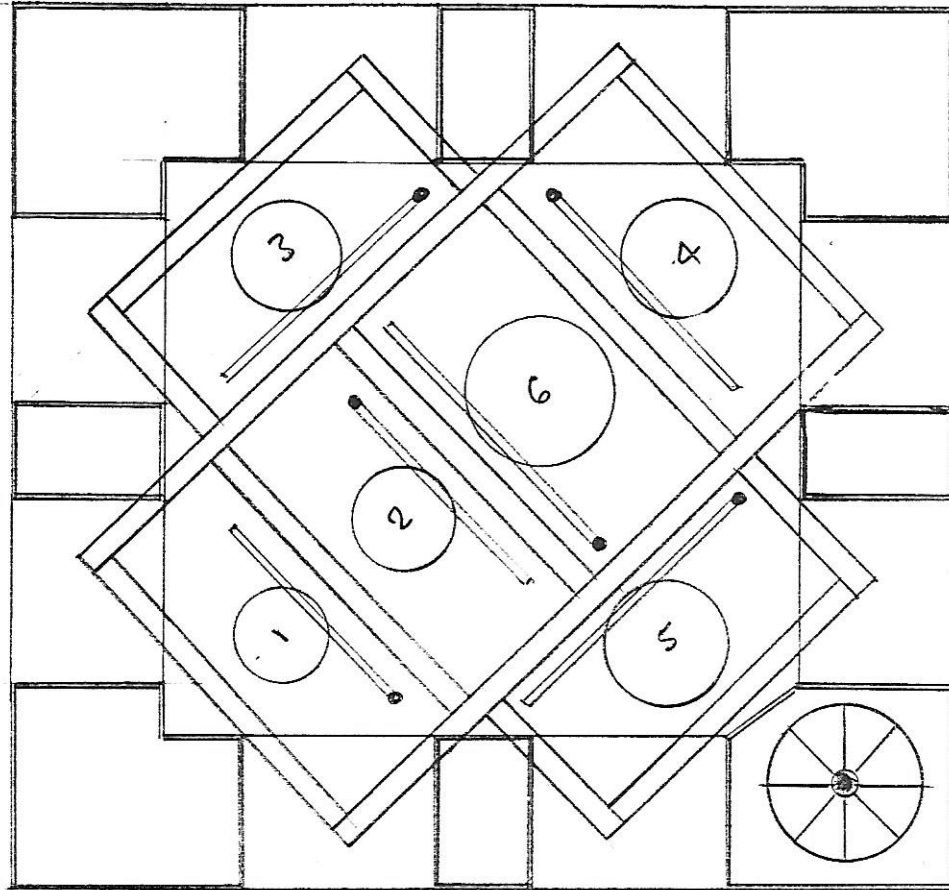
EXISTING BALL INSTALLATIONEASTNORTHSOUTH

4.01 It was evident that the timber bell frame was undergoing significant movement whilst the bells were ringing full circle with frame joints opening and closing and significant deflection being evident to the bottom frame members and top cill members. It is considered that the frame is reaching the end of its useful life and it would therefore be appropriate to consider rehanging the existing ring of bells with new fittings in a new rigid metal frame.

The existing frame is set diagonally with the tower and as a result the bells swinging full circle impose a greater horizontal load on the tower in the north south and east west directions and than they would if the frame had been set square on in the tower. The fact that there is a great deal of flexibility in the existing timber frame also means that greater horizontal loads are imposed on the tower than would be if the frame was more rigid.

Whilst there is no evidence that any significant detrimental effect on the tower is being caused at the moment by the existing ring of bells swinging full circle, the condition of the existing frame is bound to deteriorate and some damage may result. In any event the bells are made difficult to ring by the excessive movement of the frame and the small amount of movement also evident in the tower walls.

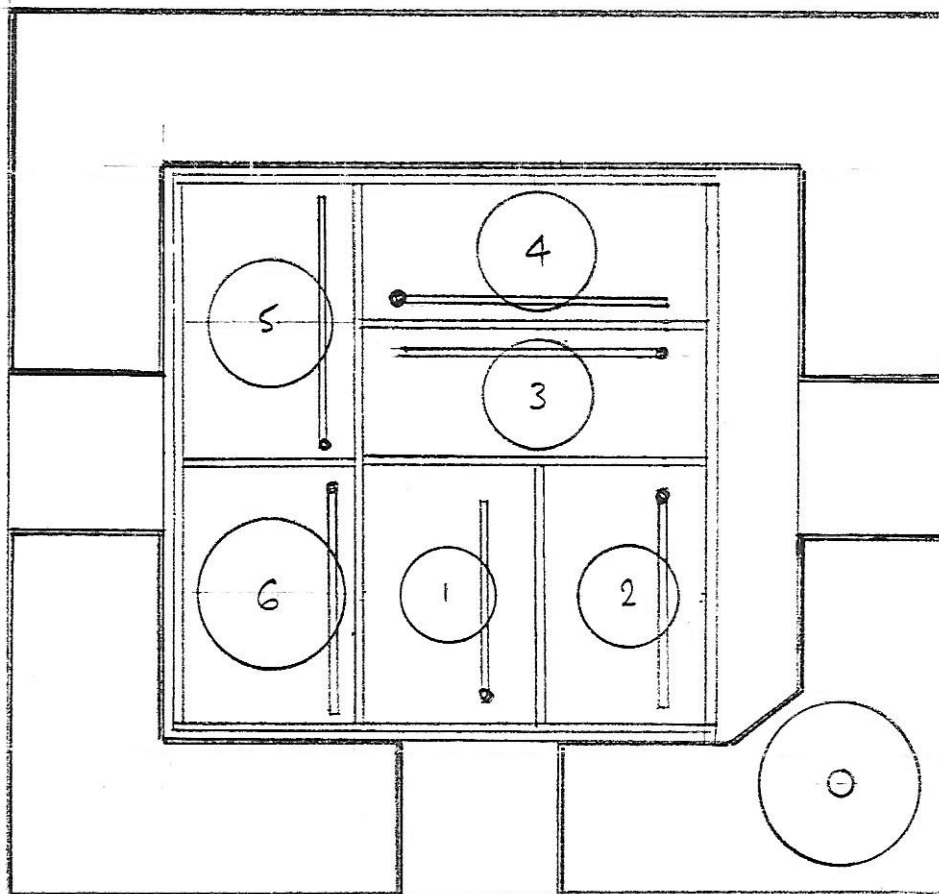
PROPOSED BALL INSTALLATION (ASSUMED)EASTNORTHSOUTH

It should be noted that the proposed bell installation, i.e the orientation of the bells, has been assumed at this stage and it should be confirmed by a specialist bell hanging company that this or a similar arrangement can be achieved.

From the figures on page A4 it can be seen that the reduction in horizontal load by rehanging the bells such that the frame is square on to the tower are reduced by approximately 50 per cent in the east west direction and approximately 80 per cent in the north south direction. Obviously this reduction in horizontal loading will reduce the horizontal deflection of the tower.

It should be noted that the new rigid bell frame should be supported on a proper grillage of foundation beams with the main foundation beams being built in to the north and south elevation walls and the secondary foundation beams being built into the east and west elevation walls.
